2023

State of the McKenzie Watershed Report

Eugene Water & Electric Board

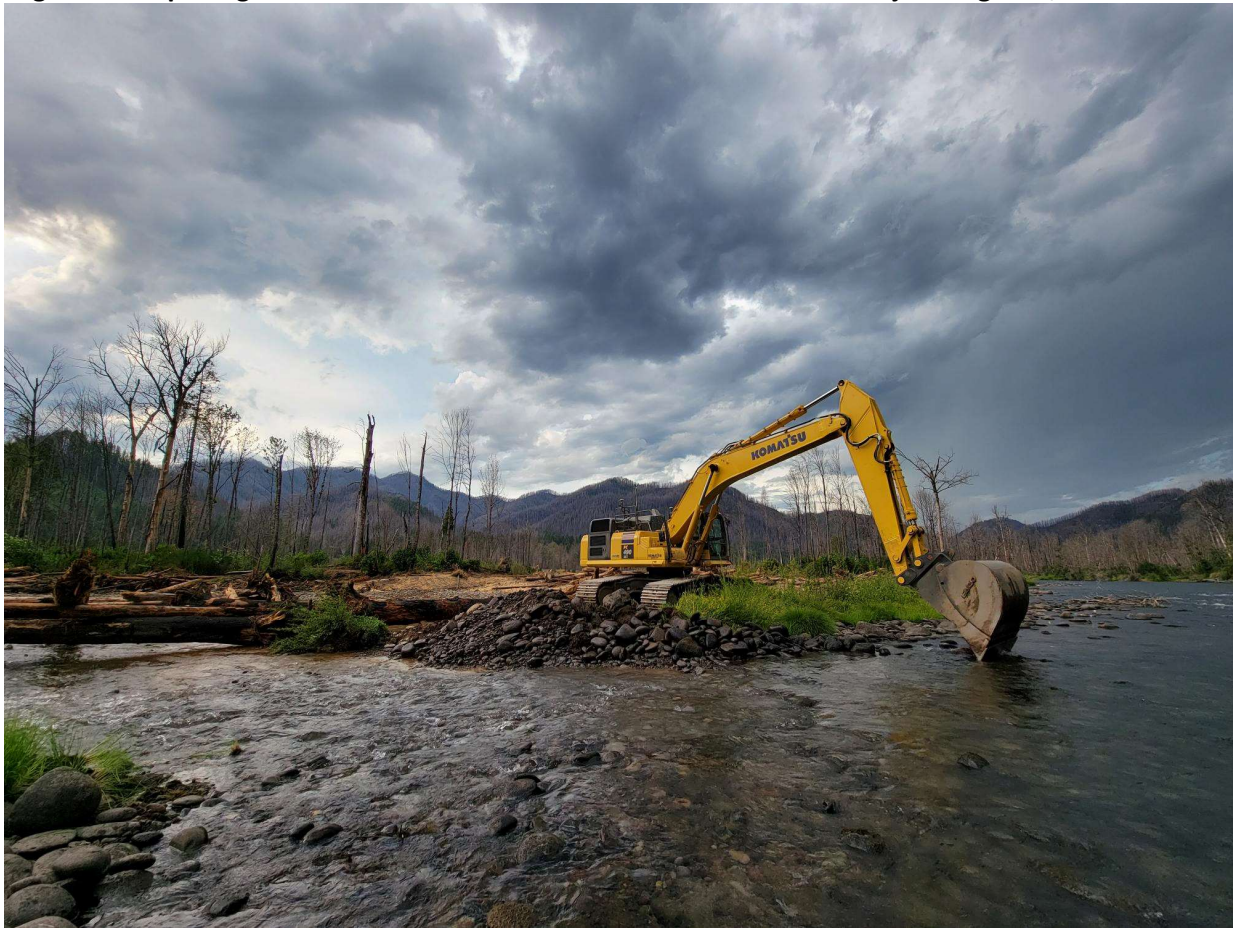
Figure 1-2: Opening the McKenzie River to the Finn Rock Restoration Project August 4, 2023

EWEB continues to work with the McKenzie Watershed Council (MWC), the McKenzie River Trust (MRT), and the U.S. Forest Service (USFS) to implement large-scale restoration projects. In 2023, partners completed the Finn Rock Phase II project (see Figure 1-2) and continued project design for Quartz Creek. These types of restoration projects have numerous benefits including: mitigating floods, turbidity, and organic carbon by spreading out and attenuating flows, dropping out sediment, increasing the uptake of nutrients and organic carbon coming from upstream severely burned landscapes, storing water, increasing habitat for fish and wildlife, increasing resiliency to wildfire, and increasing cold water refugia.

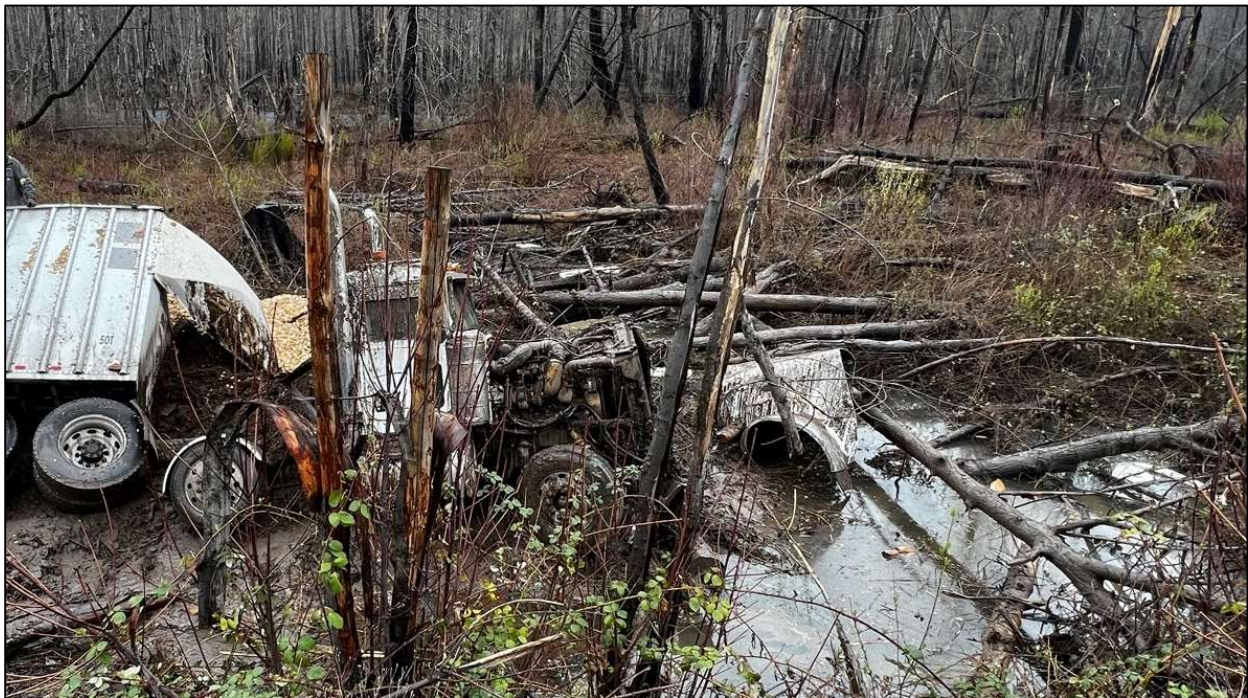
Figure 1-4: Semi-truck Crash near Finn Rock (April 2023)

Wastewater releases and hazardous material spills remain high priority threats to water quality. Several spills, mostly minor, were recorded in the watershed in 2023, including one that involved a semi-truck crash near Finn Rock. Fortunately, the driver was okay, and although the truck landed in a wetland, it avoided going directly into the McKenzie River so emergency crews had time to respond and clean the area (see Figure 1-4). The McKenzie Watershed Emergency Response System (MWERS) and years of interagency drills continue to provide a platform for effective spill communication and coordination.

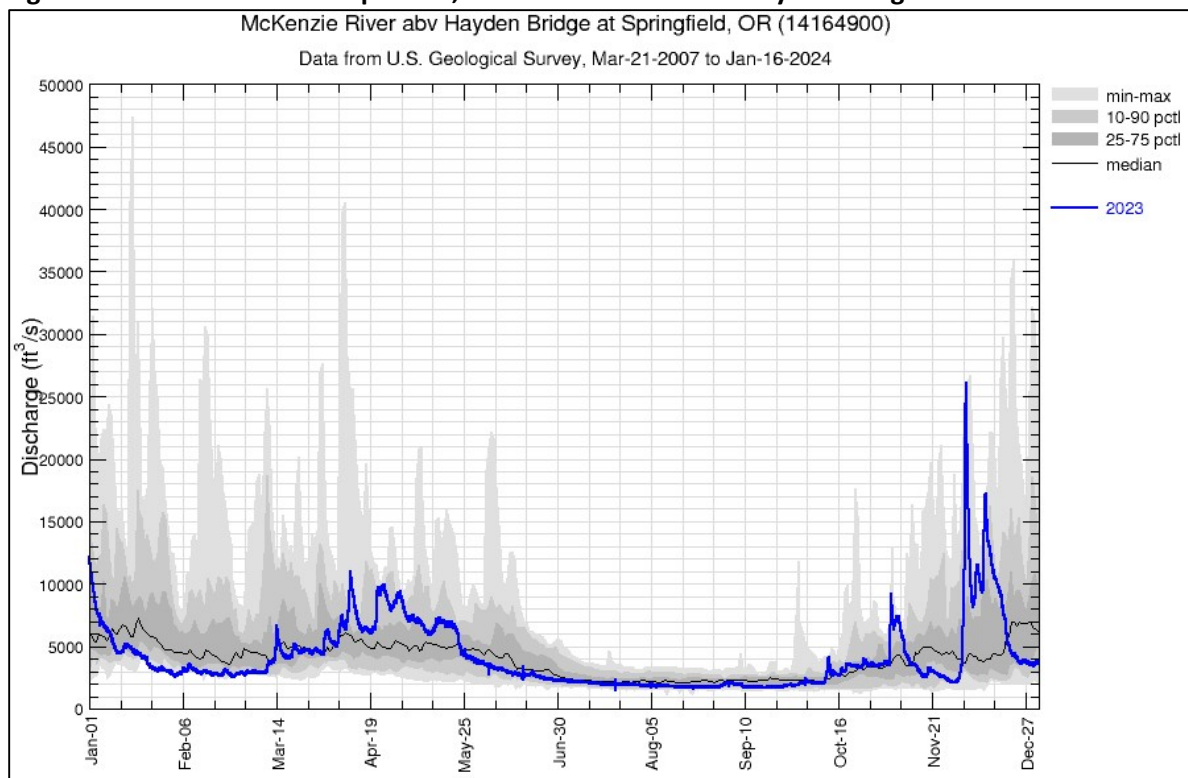
Figure 2-1: Historic Flow Comparison, McKenzie River above Hayden Bridge

Flow in the McKenzie River at Hayden Bridge during the 2023 calendar year generally stayed close or slightly below median values (see Figure 2-1). Notable exceptions include a period of lower flow during a relatively dry stretch in January and February, followed by higher-than-normal flows in March and April due to several large, spring storm events. Similar to last year, Cougar Reservoir was also bypassing higher flows in May, which contributed to higher mainstem McKenzie flows in late spring. A particularly large rain-on-snow event occurred in early December generating significant flows throughout the watershed. The event resulted in the highest observed flow (provisional USGS data) at Hayden Bridge during 2023, which peaked on December 4th at 26,100 cubic feet per second (cfs).

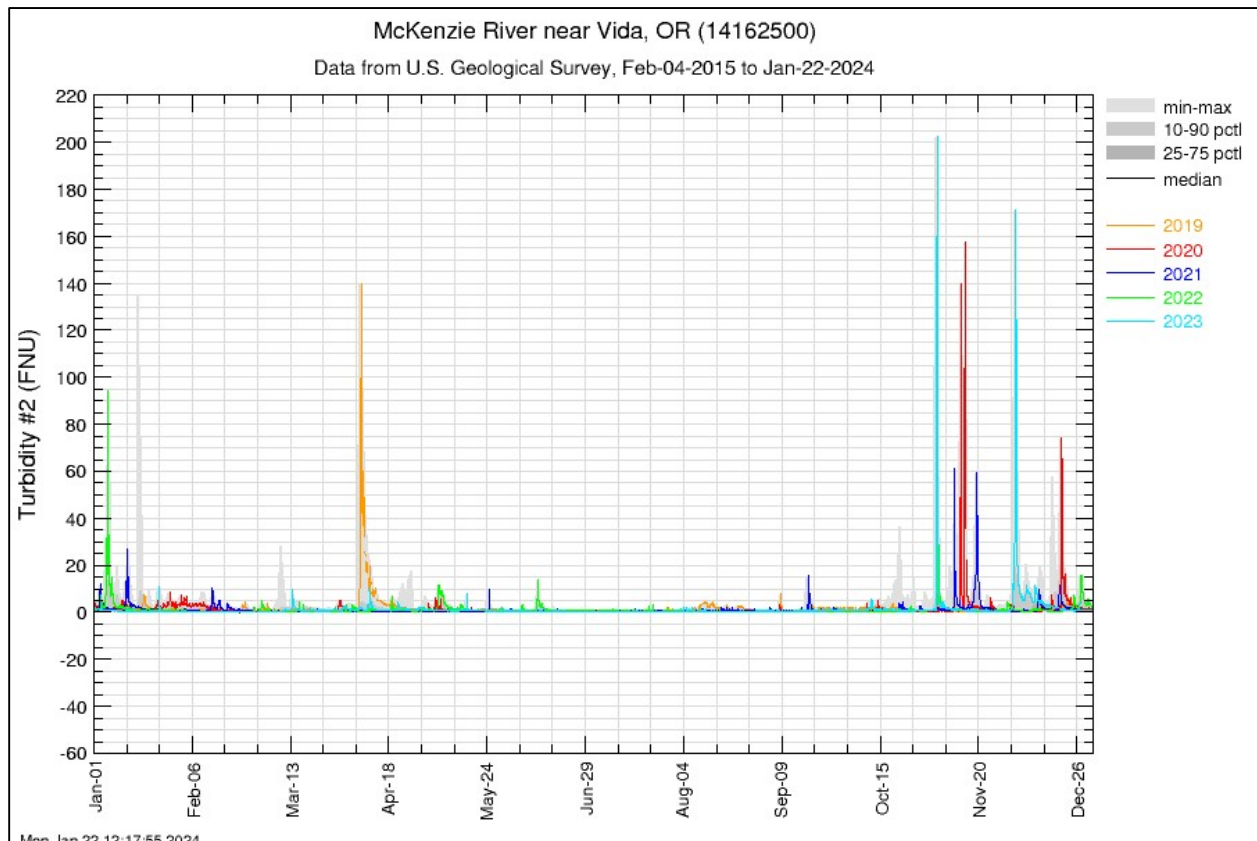
Figure 3-1: Major Turbidity Event Comparison, McKenzie River near Vida, 2019-2023

As illustrated in Figure 3-1 below by the light blue line, turbidity levels (measured in FNU) in the McKenzie River near Vida peaked in 2023 during storm events on November 4th (202 FNU) and again on December 3rd (171 FNU). Turbidity levels in the McKenzie River near Vida are typically less than 2 FNU during most of the year. One interesting note is that from 2015 to 2019 there were only two events that exceeded 50 FNU over a 5-year period. Since the Holiday Farm Fire, there have been 8 events (2 per year) exceeding 50 FNU over the past four years from 2020 through 2023.

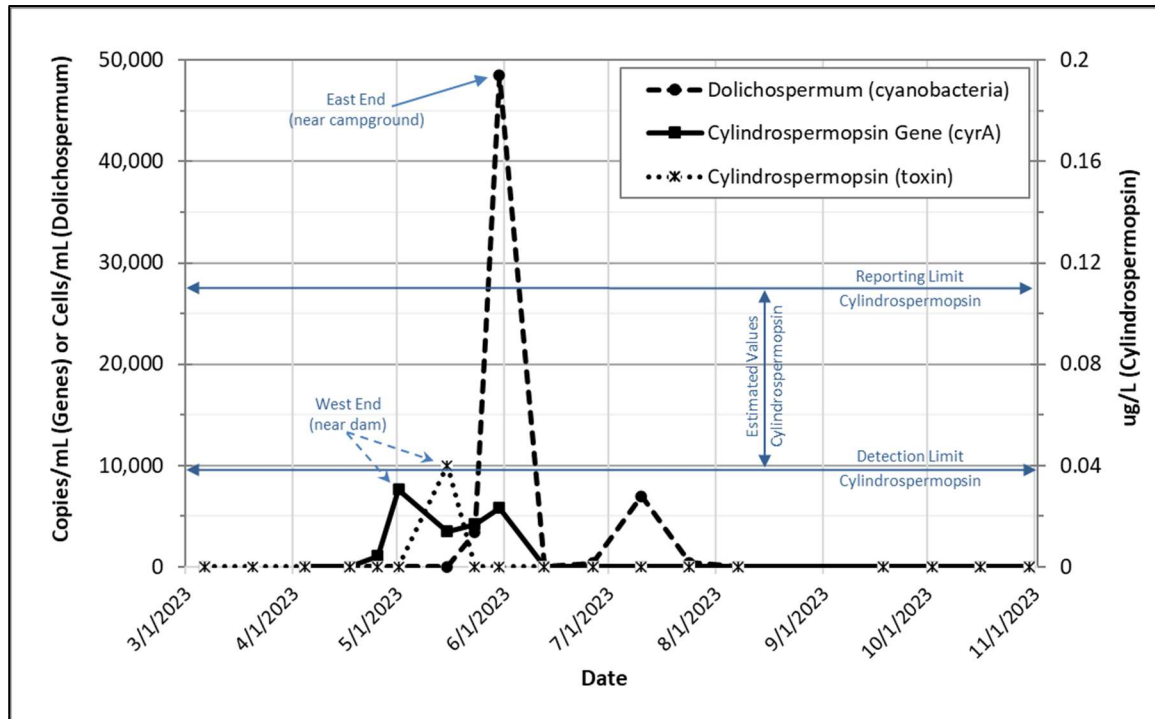
Figure 3-2: 2023 Peak HAB Results for Blue River Reservoir (across all sites)

available to collect samples in either reservoir. However, the continuous water quality profiler deployed in BRR by the USGS and Corps, was active during the 2023 fires and did not indicate any major bloom production during the closure period. Access was restored by mid-September, and although *Dolichospermum* numbers were nearly non-detect, a late season bloom of *Cyanodictyon* (likely non-toxicogenic) was observed in BRR around mid-September (12,100 cells/mL).

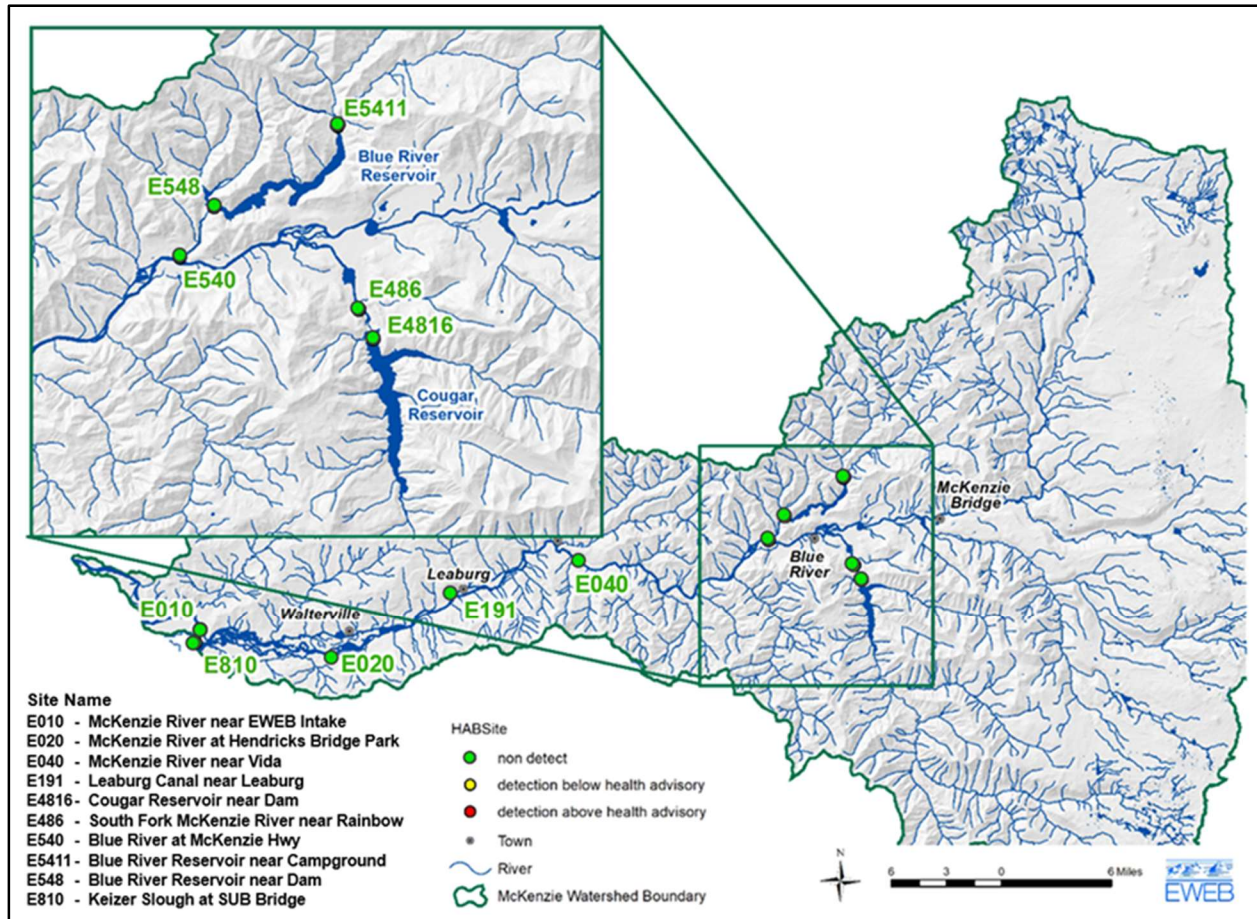
Figure 3-3: 2023 Cyanotoxin Occurrences in the McKenzie Watershed (non-estimated values only)

Certain species of cyanobacteria, including those within the *Dolichospermum* genus, are capable of producing cyanotoxins. In some cases, the genes responsible for producing specific toxins can be identified in samples using quantitative polymerase chain reaction (qPCR) methods. In 2023, toxigenic genes responsible for producing cylindrospermopsin were detected at low levels in Blue River Reservoir during consecutive sampling events from late April through late May. However, only a single (very low level) cylindrospermopsin gene detection was reported for Cougar Reservoir in 2023, occurring in early June. While the presence of toxigenic genes does not always result in measurable toxin concentrations, it is not surprising that cylindrospermopsin was not detected above the method reporting limit (.11 ug/L) throughout the McKenzie Watershed in 2023 (see Figure 3-3) given the infrequent, low-level gene detections. Only a single estimated result (value fell below the reporting limit of .11 ug/L) for cylindrospermopsin was observed in 2023 at .04 ug/L, which occurred in Blue River Reservoir near the dam on May 15. The estimated concentration barely exceeded the detection limit (.038 ug/L). For reference, the OHA drinking water threshold for cylindrospermopsin for vulnerable people is .7 ug/L, and 3 ug/L for all other people. OHA also established a health advisory recreational use value for cylindrospermopsin, which currently stands at 15 ug/L. No other toxigenic genes or cyanotoxins were detected in the McKenzie Watershed above applicable reporting limits.

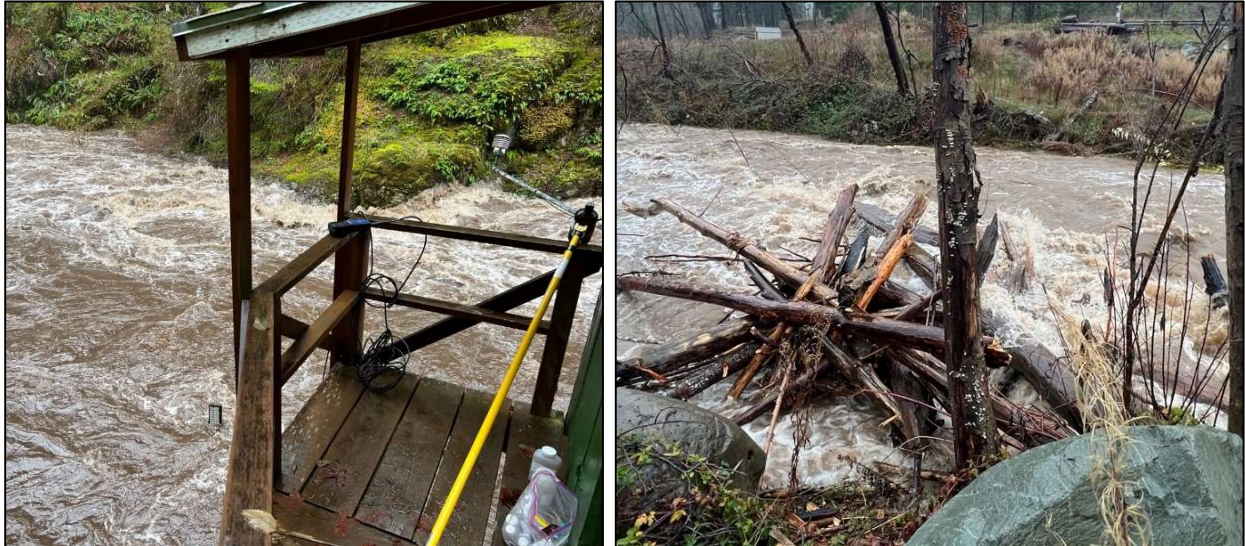
Figure 3-4: Lookout Creek (left) and Simmonds Creek (right) during Fall Runoff Events.

rainfall/runoff events during November and December in burned areas (see Figure 3-4). Marten Creek, which lies entirely within the HFF footprint, registered the highest total metal concentrations for 15 of the 19 metal species evaluated. Gate Creek reported the highest total mercury concentration at .0562 ug/L. The three exceptions were antimony, copper and zinc, with maximum total concentrations tied to two stormwater channels during an August runoff event.

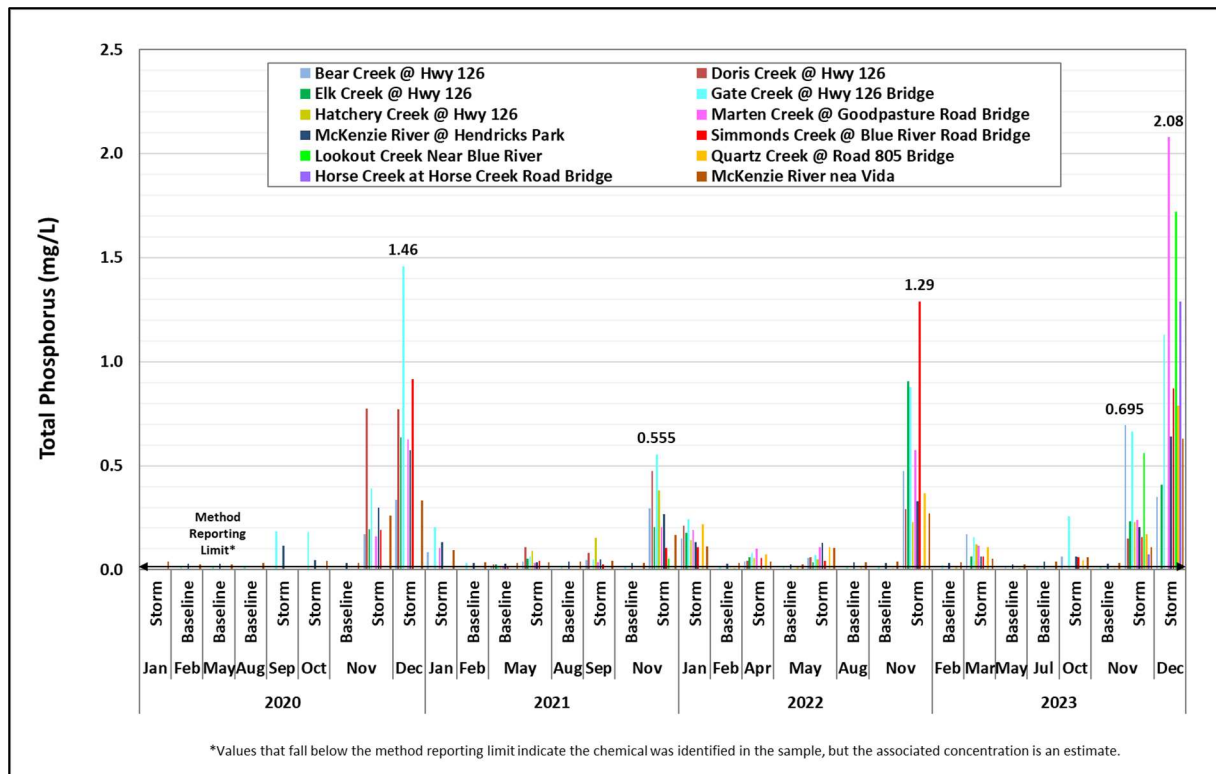
Figure 3-5: Phosphorus Results at Sites Impacted by Recent Wildfire Activity

Elevated total phosphorus and orthophosphate concentrations were observed across numerous wildfire-impacted sites during the December 2023 storm event (see Figure 3-5). Marten Creek reported the highest total phosphorus and orthophosphate concentrations in 2023 (2.089 and 1.15 mg/L respectively), followed by Lookout Creek (1.72 and 0.92 mg/L), Horse Creek (1.29 and 0.8 mg/L) and Gate Creek (1.13 mg/L and 0.5 mg/L). All other storm-related total phosphorus and orthophosphate concentrations fell below 1 mg/L, with every baseline event concentration falling below 0.1 mg/L.

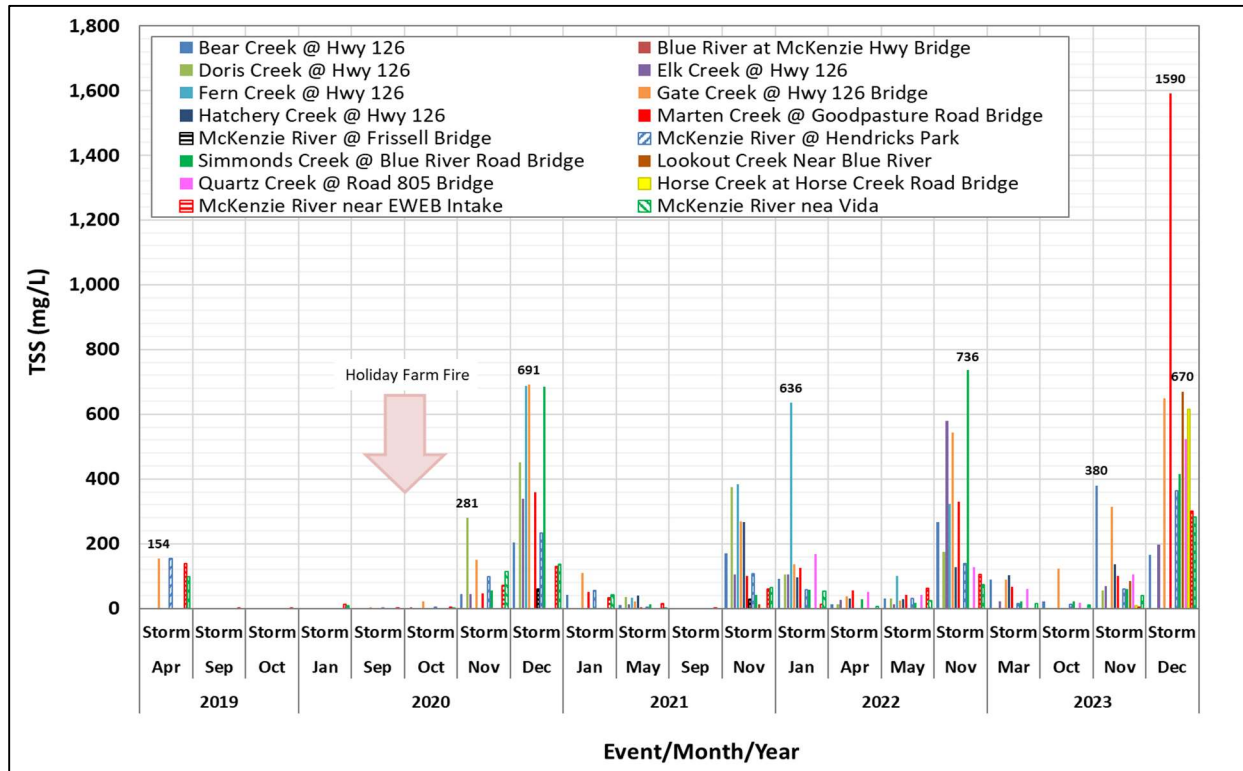
Figure 3-6: Total Suspended Solids (TSS) Across Multiple Holiday Farm Fire Sites, 2019-2023.

included Gate Creek (650 mg/L), Quartz Creek (524 mg/L) and Simmonds Creek (416 mg/L). McKenzie River mainstem sites also experienced unusually high TSS values during the December storm event after mainstem flows exceeded 25,000 cfs. Several 2023 mainstem McKenzie TSS values are the highest observed over the past 15 years. The McKenzie River near Vida recorded a TSS value of 282 mg/L (previous high was 136 mg/L in 2020), while further downstream the McKenzie at Hendricks Bridge reported 364 mg/L (previous high was 233 mg/L during 2020), before finally reaching the McKenzie near EWEB’s intake, which climbed to 300 mg/L (previous high was 138 mg/L in 2019).

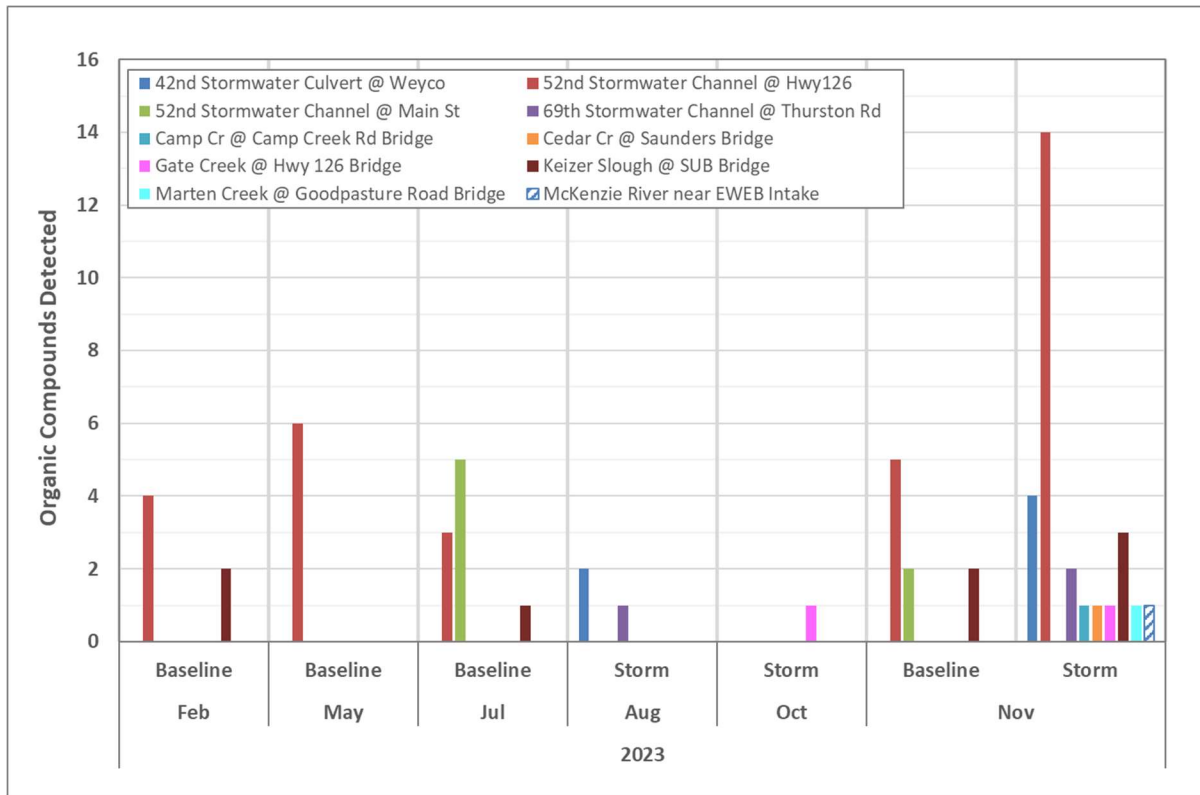
Figure 3-7: Organic Compounds Detected Above Method Reporting Limits by Site, 2023.

fire restoration and other impacts. As indicated in Figure 3-7, the 52nd stormwater channel registered the highest number of detections (14 total) for any one single event during a major storm in November.

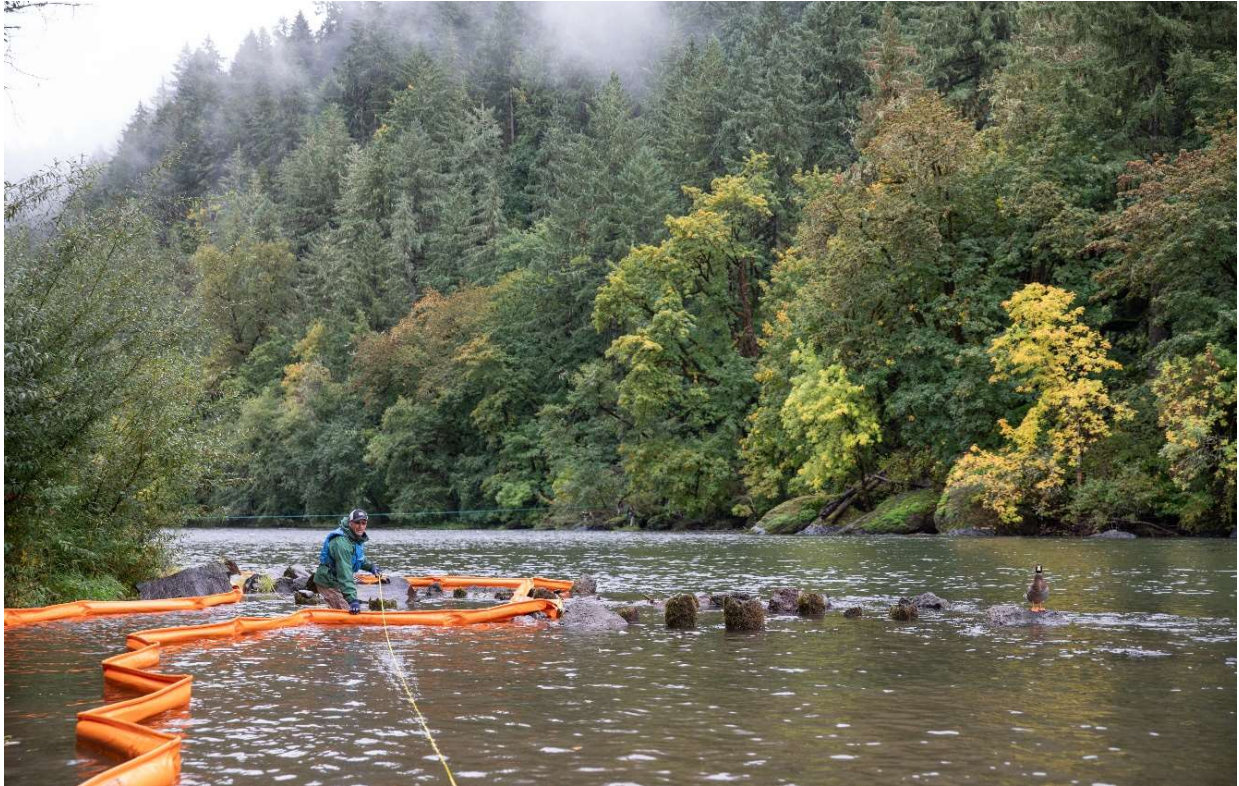
Figure 4-1: Boom Deployment Drill, McKenzie River at Hendricks Bridge County Park, 2023

EWEB staff also conducted two MWERS training webinars prior to the drill to demonstrate how the online system works, how to enter new spills, update organizational information and calculate times of travel. It is important to give refresher training periodically since most people do not use the system on a routine basis. Consultants have helped EWEB validate and add additional time of travel models to MWERS to give responders more information about potential spills and how long it may take for spills to reach EWEB’s intake or other critical resources.

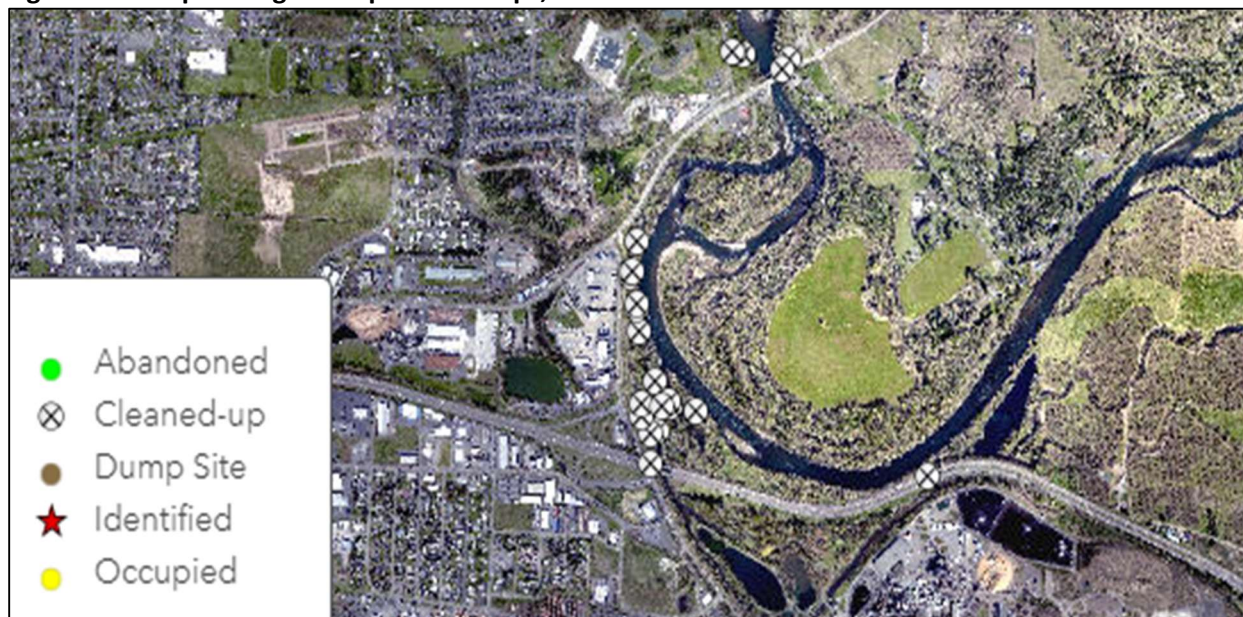
Figure 6-1: Map of Illegal Camps and Dumps, 2023

EWEB’s Source Protection staff continue to partner with Willamalane Parks, City of Springfield, and Lane County to reduce the impacts of illegal camping and dumping in riparian areas along the McKenzie River immediately above EWEB’s intake. Figure 6-1 shows the locations of illegal camps that were cleaned up in 2023. Figure 6-2 illustrates the downward trend of large, well established illegal camps due to the coordinated efforts of these agencies and use of the illegal camping application that identifies camps early and notifies agencies of a camp’s existence.

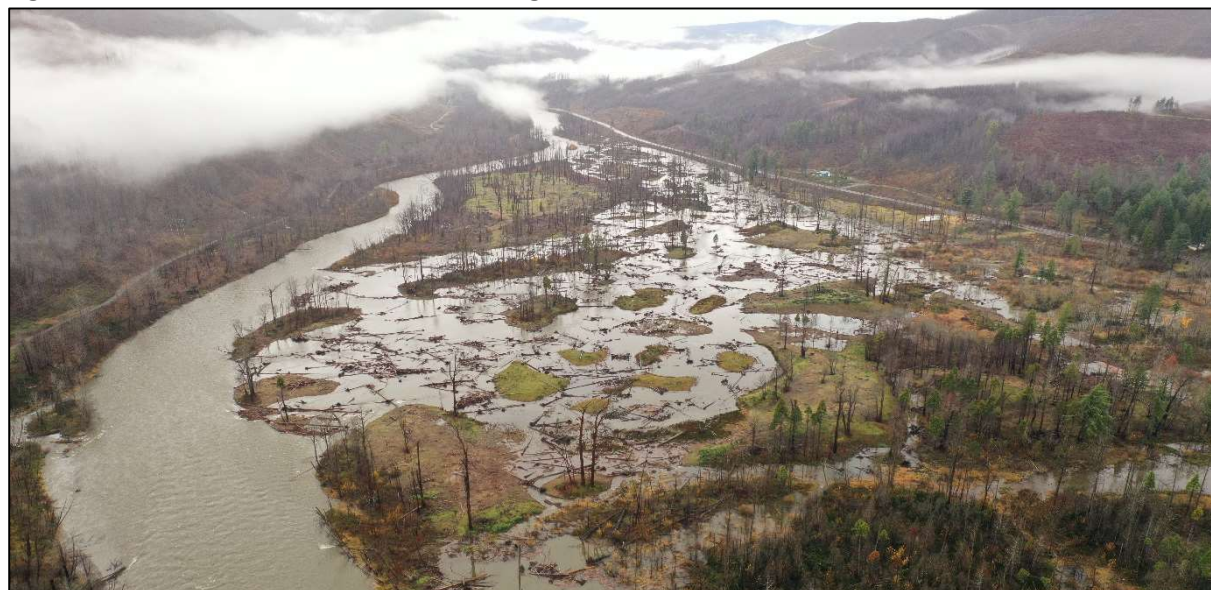
Figure 7-4: Finn Rock Reach Phase II Looking Downstream

In the summer of 2023, the McKenzie River Trust in partnership with the Willamette National Forest, EWEB, and the McKenzie Watershed Council, successfully completed Phase II of their latest 150-acre project at Finn Rock Reach of the McKenzie River. The restored floodplain at Finn Rock Reach is now a braided maze of logjams and water flowing at different velocities. By restoring the natural functions of floodplains, the watershed will become healthier, able to self-regulate with less human intervention, and will be more resilient to natural disasters (wildfire, floods, drought) and stressors of a changing climate (see Figures 7-4 and 7-5).

These types of restoration have numerous benefits including, mitigating floods, turbidity, and organic carbon by spreading out and attenuating flows, dropping out sediment, increasing the uptake of nutrients and organic carbon coming from upstream severely burned landscapes, water storage, increasing habitat for fish and wildlife, protection from fire, and increasing cold water refugia. To date, the core project team of McKenzie River Trust, USFS, McKenzie Watershed Council and EWEB have restored more than 400 acres within Finn Rock Reach. For the Finn Rock reach pre-project, there were about 5-10 Spring Chinook spawning redds a year. After phase 1 in 2021, there were 9 redds, and in 2022 there were 26. In 2023, field crews counted 65 redds, which is an amazing increase just 2 months after the project was completed. See the McKenzie River Trust website for more detailed information: <https://mckenzie-river.org/restoring-finn-rock-reach/>.

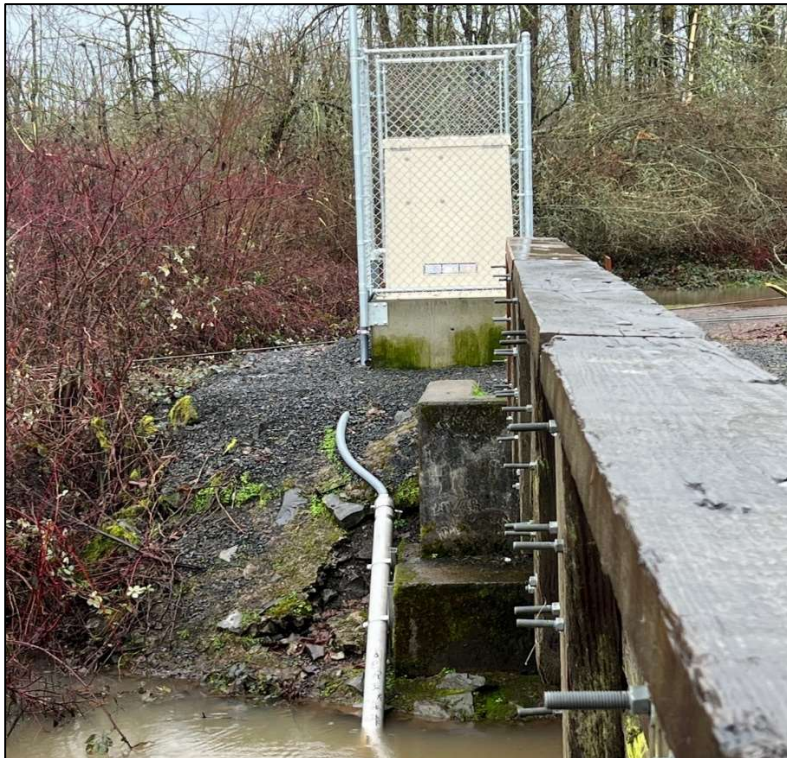
Figure 11-2: Keizer Slough Water Quality Station

Source Protection staff recently completed installation of a new water quality monitoring station in Keizer Slough, which empties into the McKenzie River just above EWEB's intake (see Figure 11-2). Real-time data from the station is currently available to staff through Aquarius and will also be added to the McKenzie River Information System (MRIS) by the end of March, which provides Hayden Bridge operators quick access to important water quality conditions upriver.
