SUBJECT: 2024 January Ice Storm – After Action Report

After Action Report

JANUARY 2024 ICE STORM

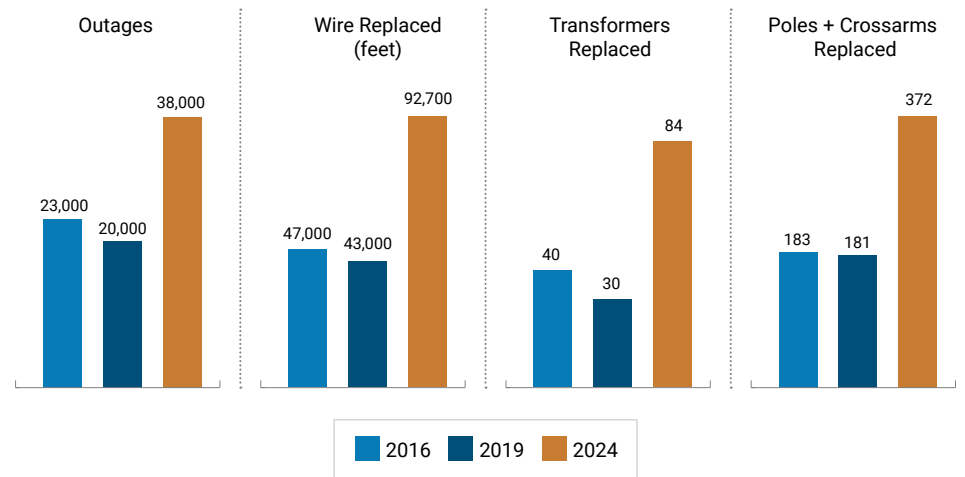
DAMAGE COMPARISON

2016	2019	2024
Days in ICS	9	9	17
Number of Line/Tree Crews	32/14	15/10	17/11
EWEB Staff	200	300	305
Injuries/Number of Recordables	5/1	6/0	11/1
Estimated Cost (millions)	\$4.2	\$3.5	\$8

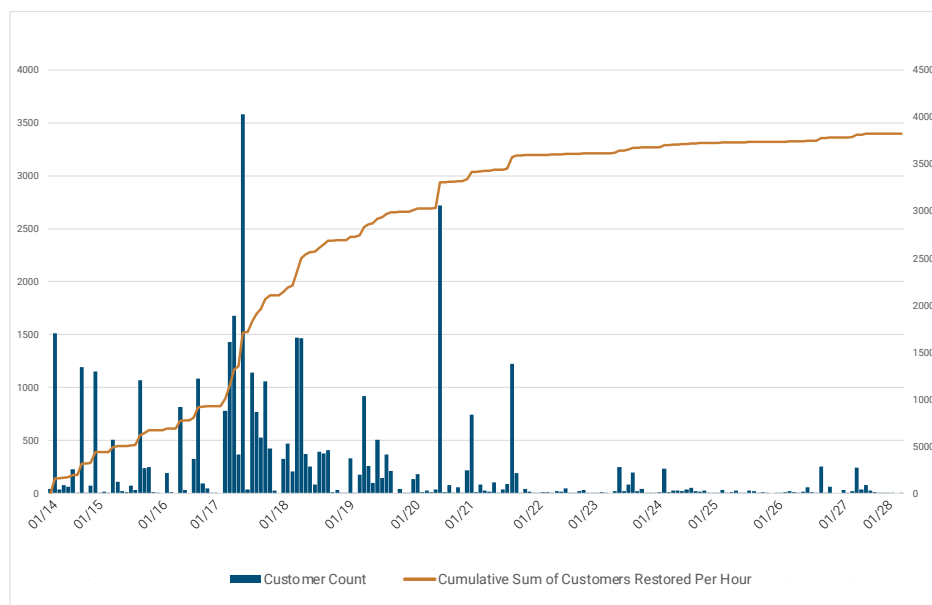
COUNTS OF ELECTRIC CUSTOMERS RESTORED PER HOUR AND CUMULATIVE CUSTOMERS RESTORED BETWEEN JAN. 14 AND JAN. 28

In total, 359 field and office staff participated in the ICS emergency response, including 54 contracted linemen. Approximately 29,000 labor hours were billed. Damage from the storm resulted in approximately \$8 million in restoration costs (parts, materials, staff time and contracted labor).

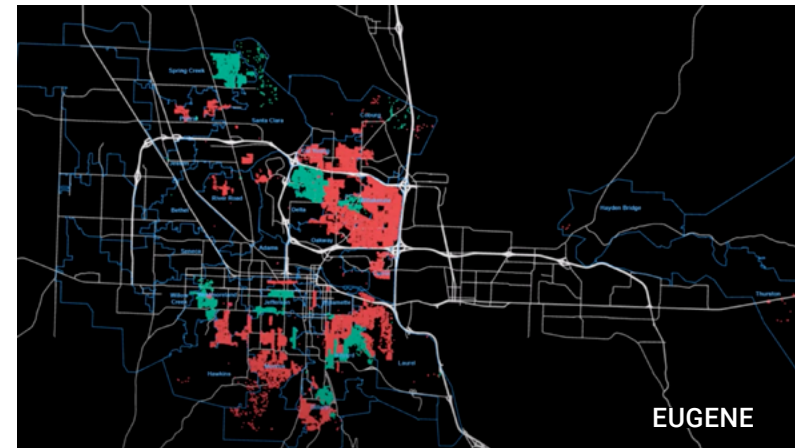
OUTAGES AND RESTORATIONS AS OF 1:05 A.M. ON WEDNESDAY, JAN. 17, 2024

As forecasted, the freezing rain caused another significant round of outages overnight. While EWEB worked to restore power for thousands of customers over the past few days, the damage sustained in the last 24 hours was a setback for the progress previously made. **Power outages peaked at 24,000 on Wednesday morning.**

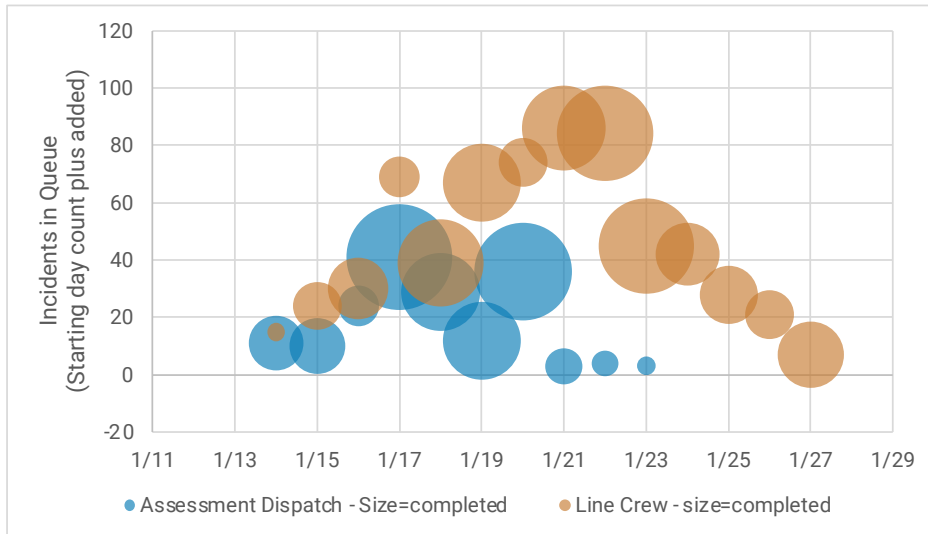
STACKED WORKLOAD FOR ASSESSMENT CREWS & LINE CREWS

In the initial phase of the event, crews spent a majority of the time making feeder and switching restorations, as well as responding to downed wire reports. As the event progressed into the assessment stage, assessment progress accelerated, as seen from Jan. 17 to Jan. 20.

The Line Crew Planning role of printing and delivering work packages to Line Crew Area Commanders peaked the following day, Jan. 21. Active assessments were completed on Jan. 23, as shown by the flat line at the zero-level following assessment completion to the end of the event.

From Jan. 20 to the end of the restoration period, Line Crews were actively repairing and restoring customers. As the restorations moved to single premises and crews were demobilized, the resourcing level of the crews decreased substantially.

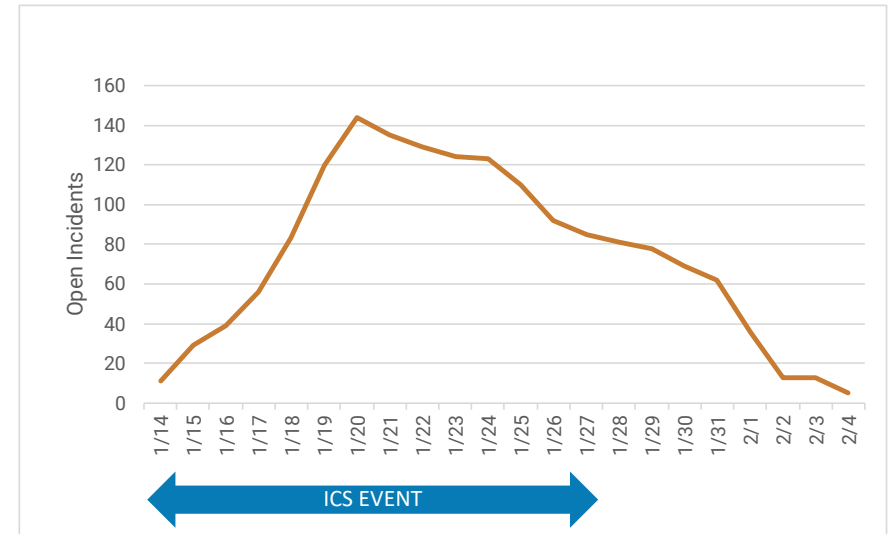
ELECTRICIAN NEEDED WORK QUEUE

As restoration efforts slowed to single premise "Needs Electrician" responses, the restoration pace slowed.

This queue builds throughout the storm recovery efforts as customer damage is reported during assessment by phone and from restoration activities. The queue then drops dramatically as customers actively acquire repair services towards the end of the event as neighborhood power is brought back.

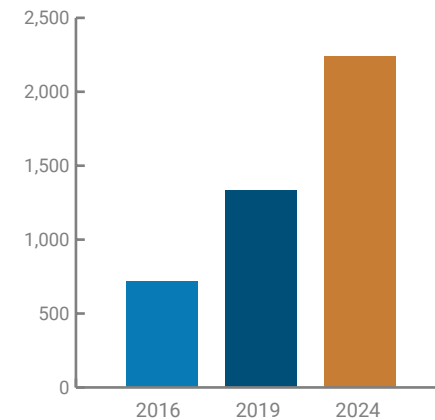
RATIO OF RESTORATIONS BY CREW

Due to EWEB's day-to-day Asset base and Territory size, staffing is not at the level needed in normal operations to respond to large events without assistance. Mutual aid or contracted crews will continue to be a strategy for accelerated outage restoration. **This storm saw an increase in the ratio of restorations per crew, though this is influenced by the type of damage experienced, this storm saw close to double the previous damage to capital equipment that requires more time to replace than wire alone (transformers and poles).**
