2021

State of the McKenzie Watershed Report

Eugene Water & Electric Board

February 2022

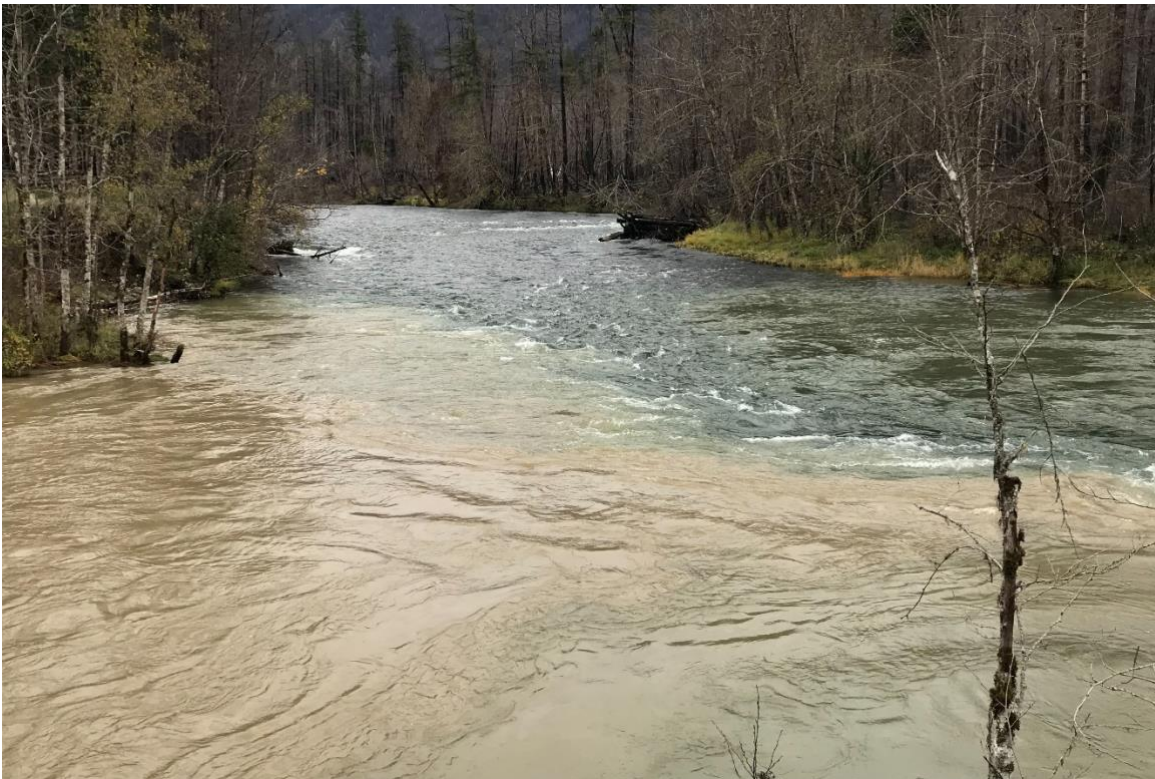
Figure 1-3: Major Turbidity Event in Blue River (McKenzie in background/Blue River in foreground)

Reservoir operations by the Corps of Engineers in Blue River Reservoir brought the lake level down rapidly in November. However, water levels fell below the water control diagram at one point, exposing lakebed sediments to the scouring forces of channel flow. The result was a dramatic rise in turbidity levels downstream in both Blue River and the McKenzie River. Turbidity levels (the cloudiness of the water) in Blue River reached values above 500 Formazin Nephelometric Units (FNU) which rivals some of the highest turbidity values observed immediately after the Holiday Farm Fire during storm events. Increased turbidity was observed in the McKenzie River (Figure 1-3) all the way down to Hayden Bridge for several days.

Similar to 2020, most peak values observed in 2021 were associated with prolonged rain events in urban areas of eastern Springfield or within the HFF area. An important departure from previous years was the Blue River Reservoir turbidity event this past November. Samples collected during this unusual event resulted in some of the highest values ever observed by Source Protection staff in the McKenzie Watershed for several analytes. Fortunately, the event was relatively short-lived and only lasted for a few days.

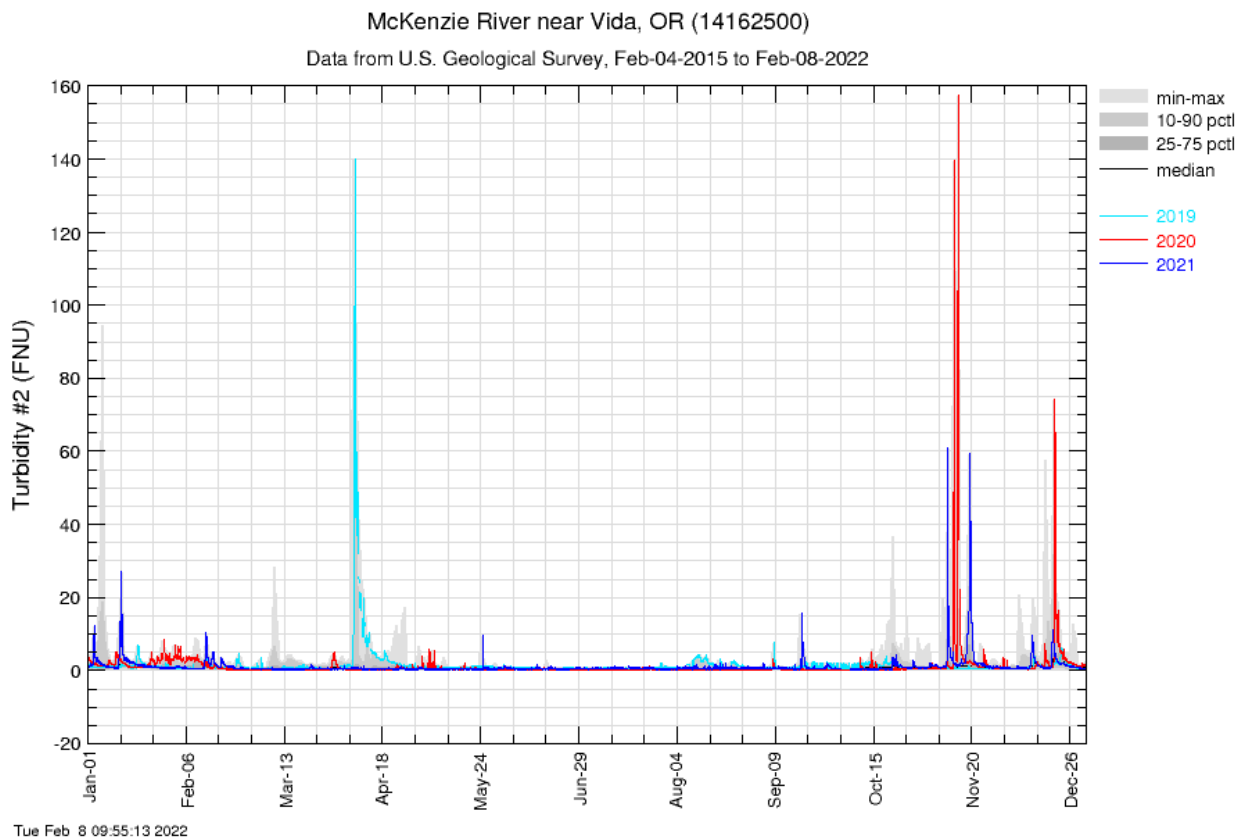
Figure 3-1: Major Turbidity Event Comparison, McKenzie River near Vida, 2019-2021

As illustrated in Figure 3-1 by the blue line, turbidity levels (measured in FNU) in the McKenzie River near Vida peaked in 2021 during a storm event on November 11th (61 FNU) and again on November 19th (59 FNU) due to an erosional event in Blue River Reservoir. Over the past three years turbidity levels have been elevated during certain runoff events in the McKenzie River near Vida. In 2020, turbidity climbed to 158 FNU during a heavy rain event following the Holiday Farm Fire, and 140 FNU after a significant rain on snow event in April of 2019. Turbidity levels in the McKenzie River near Vida are typically less than 3 FNU during most of the year.

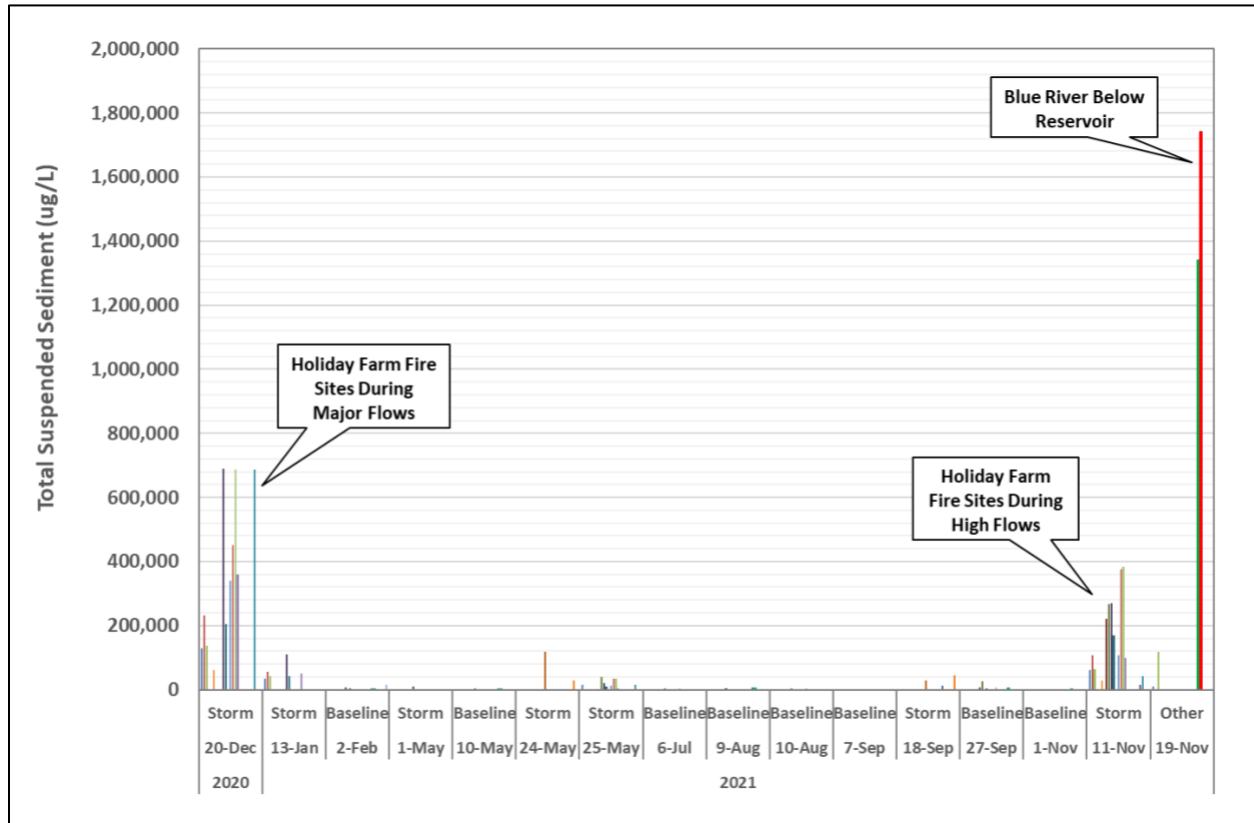
Solids can carry contaminants and pathogens through the watershed impacting ecosystem function as well being a concern for drinking water treatment. Results for total suspended solids (TSS) and total solids (TS) were generally typical across most sites throughout 2021. Modest TSS and TS increases were observed during rainfall events, with the most significant increase occurring during high flow conditions in November. However, similar to other analytes previously discussed, the Blue River Reservoir turbidity event generated some of the highest sediment loads observed across the entire McKenzie Watershed over the past 20 years. TSS values downstream of the reservoir reached 1,740 mg/L this past November, compared to the peak TSS value of 691 mg/L reported for Gate Creek during major flow conditions in 2020 immediately after the HFF (See Figure 3-6).

Figure 3-6: Total Suspended Sediment Concentrations Across Multiple Sites, 2021. The Major Flow event in 2020 was a large winter storm, and the high flow event in 2021 was the first runoff event of 2021.

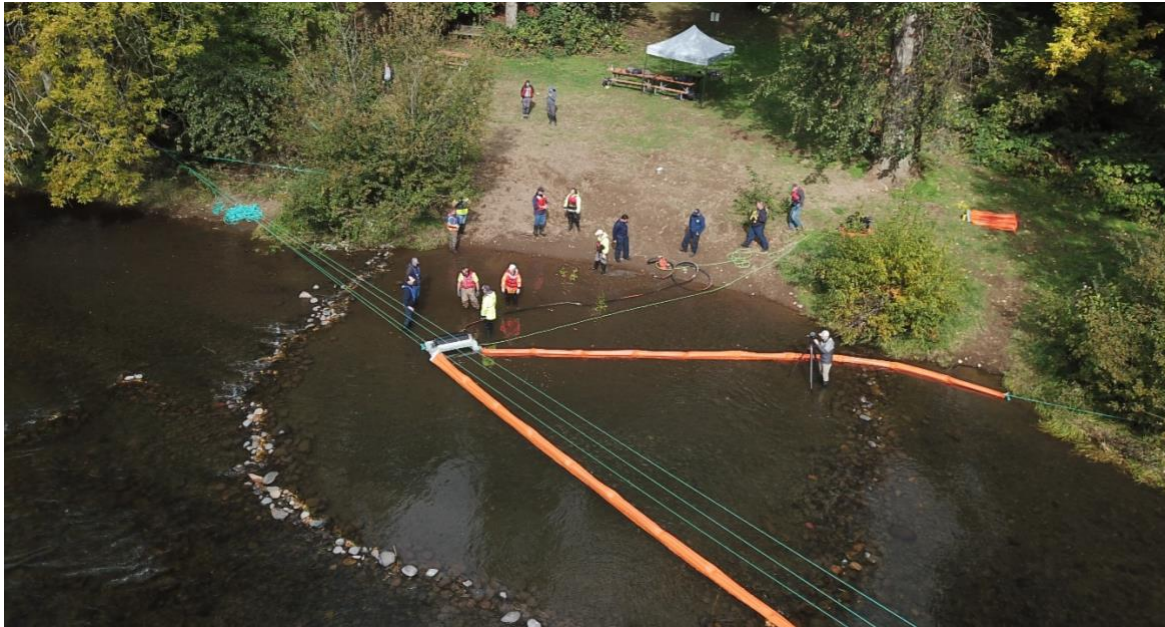
Figure 4-1: Boom Deployment Drill, McKenzie River at Hendricks Bridge Park, 2021

EWEB worked with multiple partners to coordinate a multi-agency spill response drill on the McKenzie River this past fall (see Figure 4-1). Equipment from the McKenzie Watershed Emergency Response System (MWERS) was used to deploy boom across a segment of the river. The drill gives first responders an opportunity to familiarize themselves with equipment and to test out new response strategies.
