2020

# State of the McKenzie Watershed Report

Eugene Water & Electric Board

February 2021

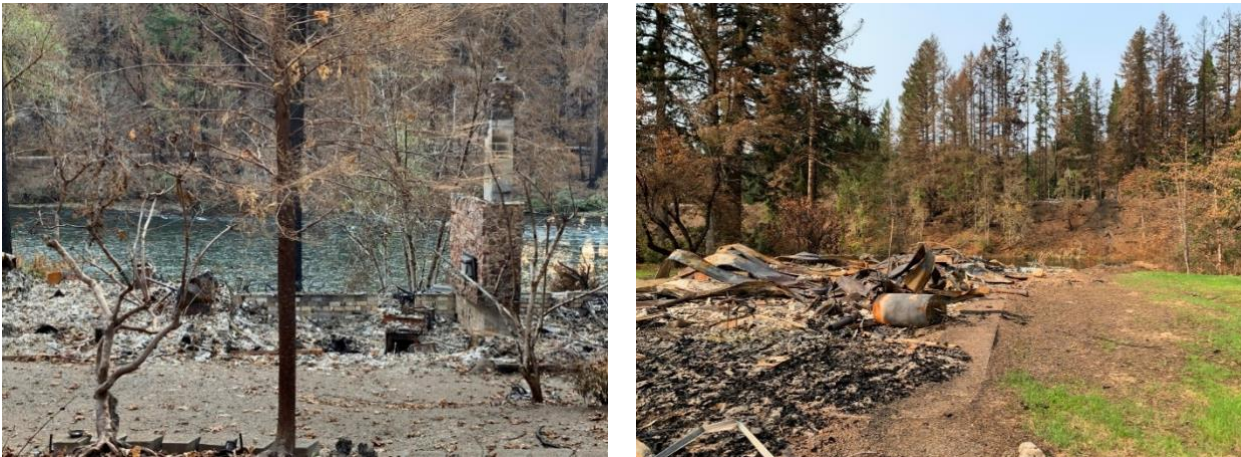
**Figure 1-3: Residences Destroyed by the Holiday Farm Fire**

High winds and extremely dry conditions fanned flames that destroyed hundreds of homes and an untold number of trees within a matter of days. Although local, state, and federal agencies and organizations are conducting restoration efforts throughout the fire zone, the impact of the fire on communities, habitat and water quality will last for years.

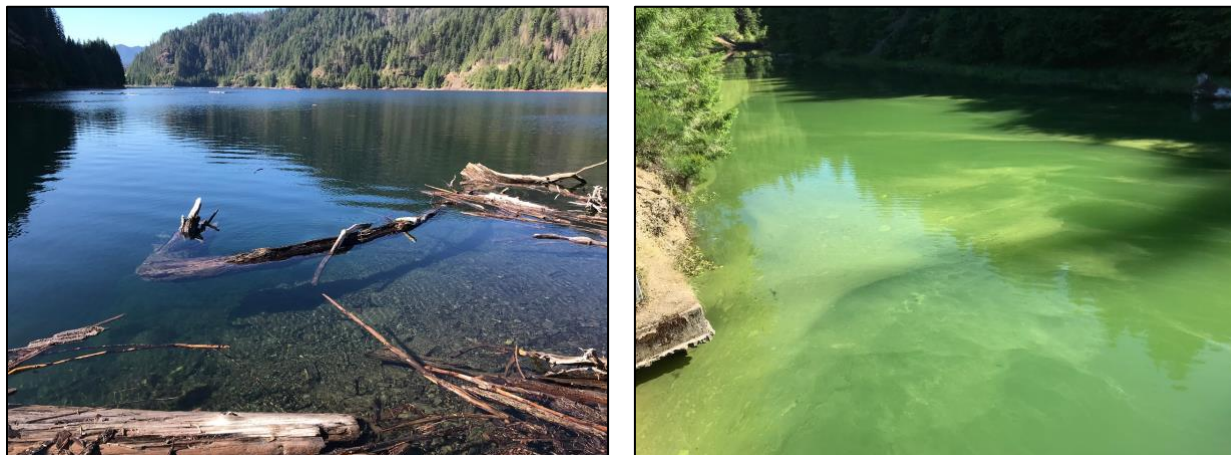
Figure 3-3: Cougar Reservoir (left) and Blue River Reservoir (right) on 7/13/2020

Cyanobacteria blooms in 2020 in both Blue River Reservoir (BRR) and Cougar Reservoir (CR) followed a similar pattern observed in 2019. A significant *Dolichospermum* bloom first appeared in BRR beginning in April. By the beginning of June the bloom had largely faded. *Dolichospermum* numbers increased again later in June in both reservoirs and remained elevated in BRR into July before dissipating (see Figure 3-3). HAB monitoring efforts were put on hold in September during the Holiday Farm Fire area closure but were resumed in October and November. In early fall BRR had a noticeable late season *Gloeotrichia* bloom and CR had elevated *Dolichospermum* concentrations.

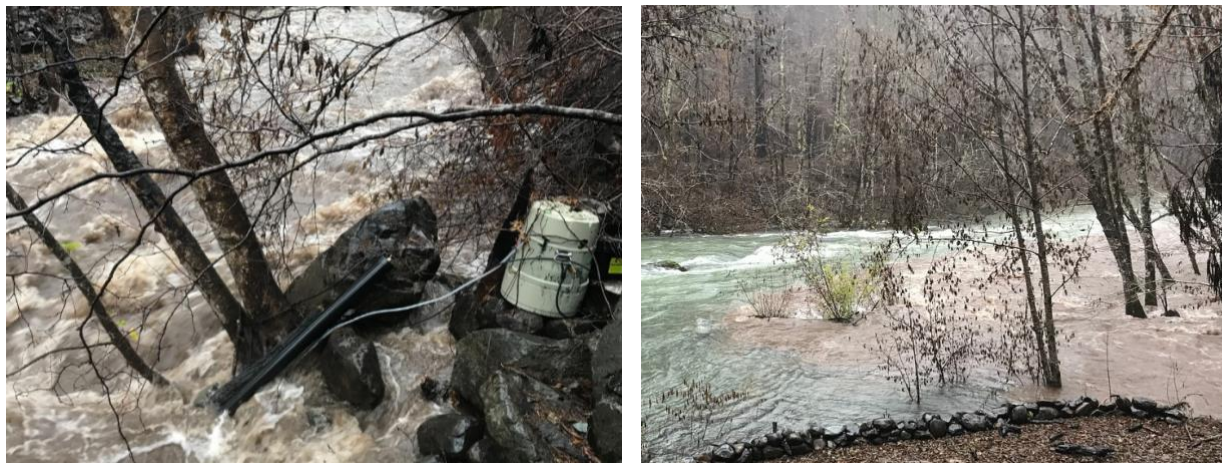
**Figure 3-4: Simmonds Creek - Monitoring Site (left) and Entering Blue River (right), 12/20/2020**

All routine baseline sampling events were completed as scheduled in 2020. However, due to limited staff mobility during the first wave of Covid-19 restrictions, staff were unable to collect a round of spring storm samples within the urban interface. The Holiday Farm Fire further impacted storm monitoring priorities in the fall. Sampling efforts during the first few rain events in September focused on urban and rural sites west of the fire. The urban/rural focus was largely due to limited access within the fire perimeter, as well as assessing impacts from significant ash fall across the area. For the October storm, more attention was placed on sites within and immediately downstream of the fire perimeter. For large storm events in November and December, enhanced access within the fire perimeter allowed focused sampling across a range of different tributary sizes (see Figure 3-4), as well as mainstem McKenzie sites.

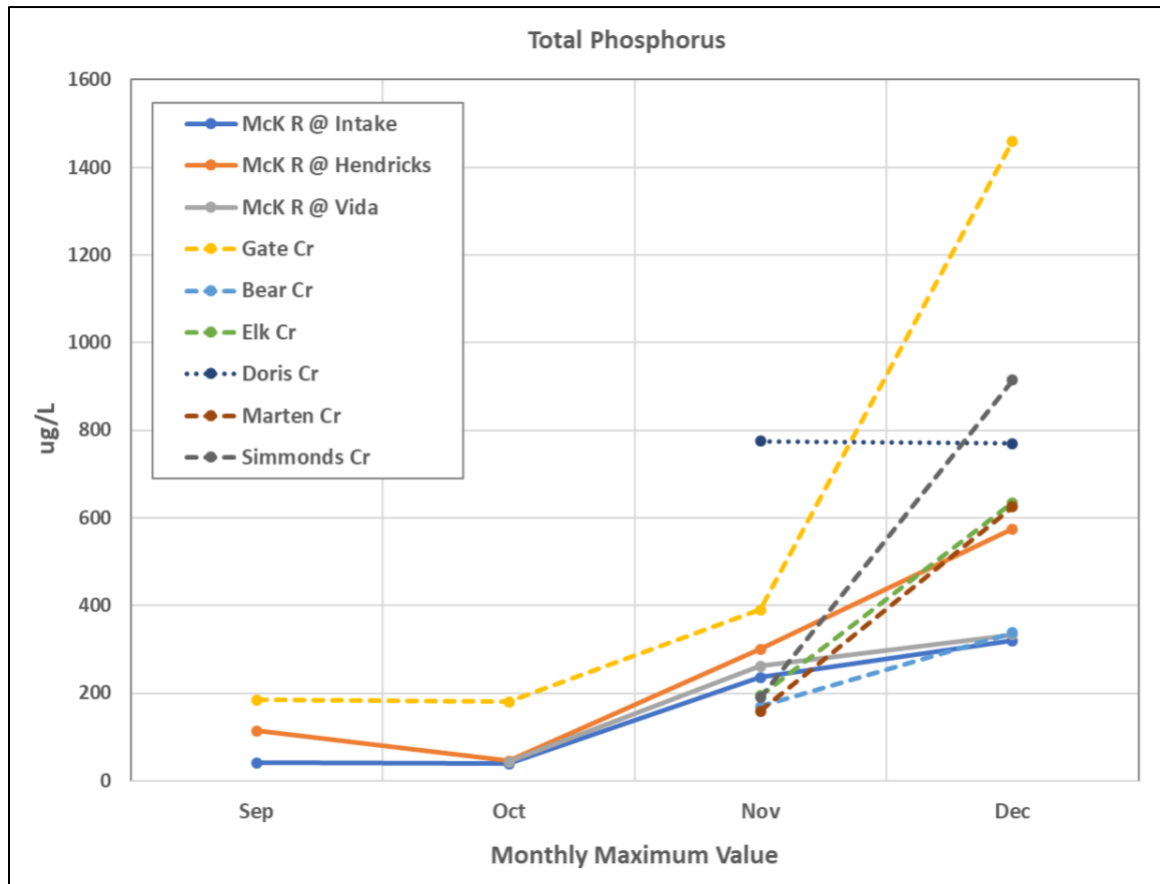
**Figure 3-5: Monthly Maximum Total Phosphorus Concentrations Related to the Holiday Farm Fire**

Significant nutrient increases were observed across many urban sites and tributaries within the burn area during major runoff events. Similar to dissolved metal peak concentrations, most maximum nutrient concentrations were observed at E524. One notable exception is total phosphorus, where the maximum concentration was observed in Gate Creek. Although nitrate levels may have peaked in November, total phosphorus appears to be on an upward trend across many sites (see Figure 3-5). Phosphorus is considered a limiting nutrient for many algae species, including cyanobacteria. One possible consequence of elevated phosphorus levels is increased primary benthic growth in local tributaries and mainstem reaches. Some of the highest values for both total and dissolved organic carbon, 76,000 and 91,000 ug/L respectively, were reported at E524. These values are extremely high and may reflect significant ash/soot deposition on impervious surfaces and subsequent flushing.

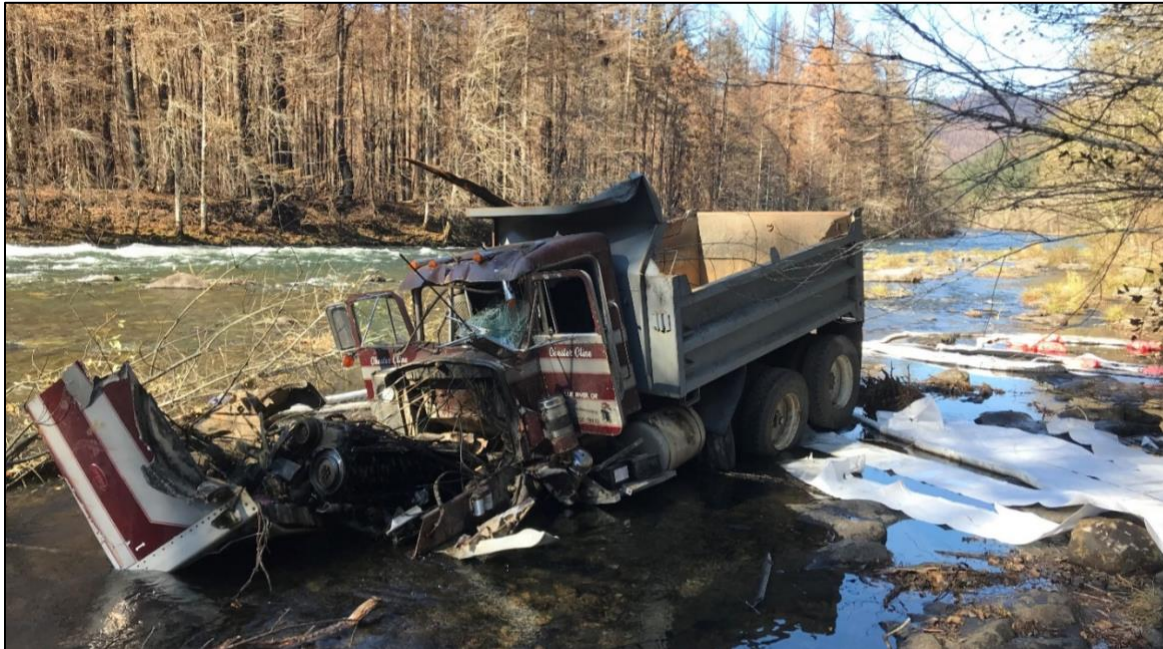
**Figure 4-1: Truck Crash in the McKenzie River**

Several significant truck accidents in 2020 resulted in environmental releases (see Table 4-1). A semi-truck accident last January, that resulted in a significant diesel release, occurred only a few hundred feet from the McKenzie River. Another accident involving a dump truck in October created an oily sheen that traveled several miles downstream (see Figure 4-1). EWEB staff deployed absorbent booms and pads at Leaburg Dam to collect a very light sheen. Also evident in the aftermath of the fire was the untold number of chemical containers that were either totally or partially burned, potentially releasing contents to surrounding soils.

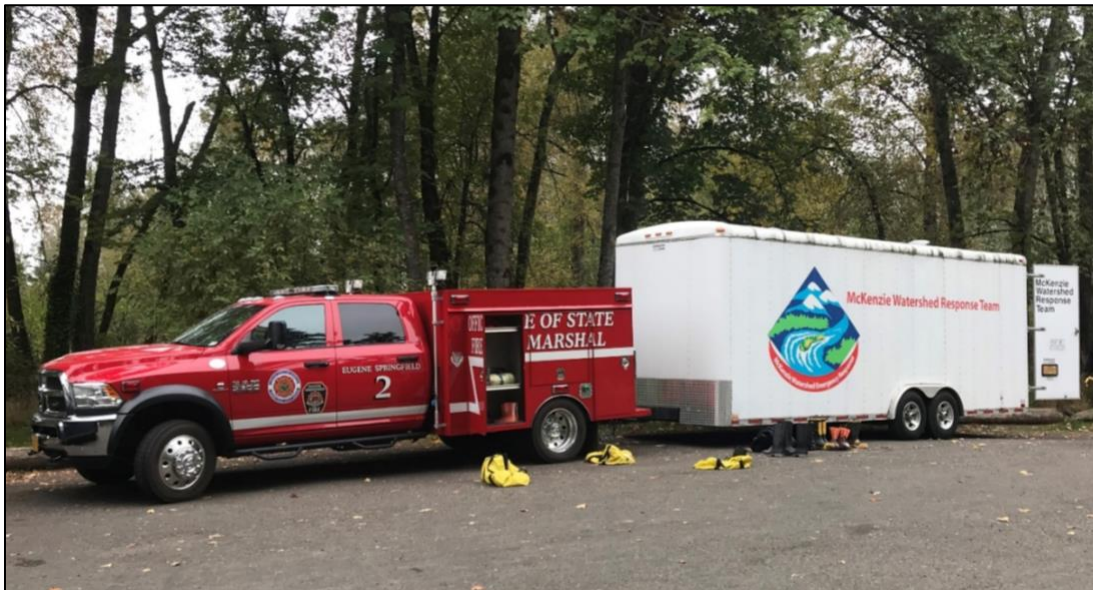
**Figure 4-2: Boom Deployment Drill, Willamette River, 2020**

Although EWEB staff and many other partners were busy responding to the Holiday Farm Fire, members of the Region II Hazmat team conducted a spill drill on October 8<sup>th</sup> along the Willamette River. Equipment from the McKenzie Watershed Emergency Response System (MWERS) program was used to deploy boom across a segment of the river and give Eugene and Springfield Fire staff a chance to practice deployment techniques (see Figure 4-2). A full interagency drill will be conducted in 2021.

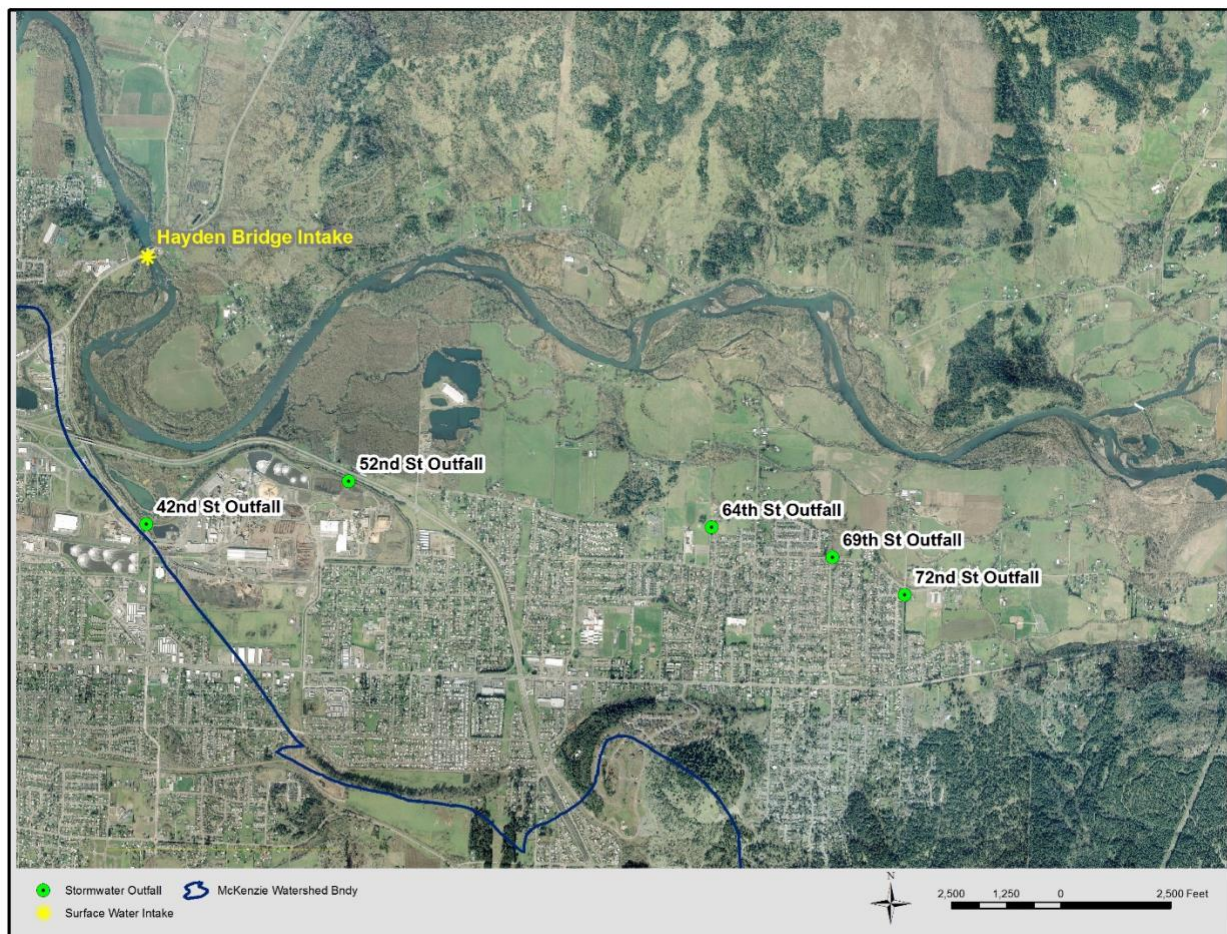
**Figure 5-1: Stormwater Outfalls in East Springfield**

Urban runoff is a concern especially in the lower part of the McKenzie Watershed which includes parts of East Springfield. Several stormwater outfalls (i.e., 42<sup>nd</sup> St., 52<sup>nd</sup> St., 64<sup>th</sup> St., 69<sup>th</sup> St., and 72<sup>nd</sup> St.) discharge into Cedar Creek and Keizer Slough, and then into the McKenzie River just upstream from EWEB's intake (see Figure 5-1). This area also contains a number of Springfield Utility Board (SUB) and Rainbow Water municipal well fields.

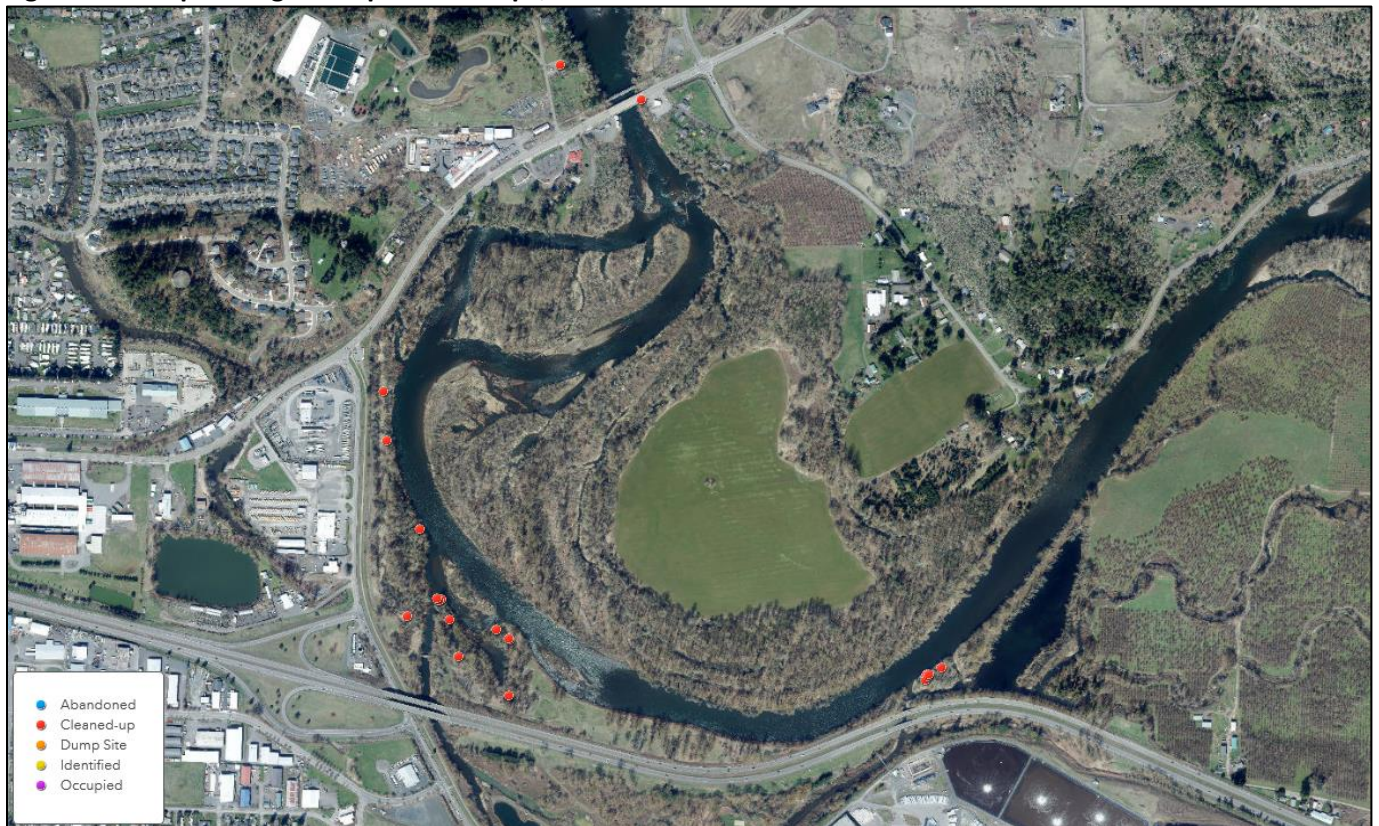
**Figure 6-1: Map of Illegal Camps and Dumps, 2020**

EWEB’s Source Protection staff continue to partner with Willamalane Parks, City of Springfield, and Lane County to reduce the impacts of illegal camping and dumping in riparian areas along the McKenzie River immediately above EWEB’s intake. Figure 6-1 shows the locations of illegal camps that were cleaned up in 2020. Figure 6-2 illustrates the downward trend of illegal camping due to the coordinated efforts of these agencies and use of the illegal camping application that identifies camps early and notifies agencies of a camp’s existence. Although Covid-19 precautions and the Holiday Farm Fire impacted efforts in 2020, coordinated surveys are expected to resume in 2021.

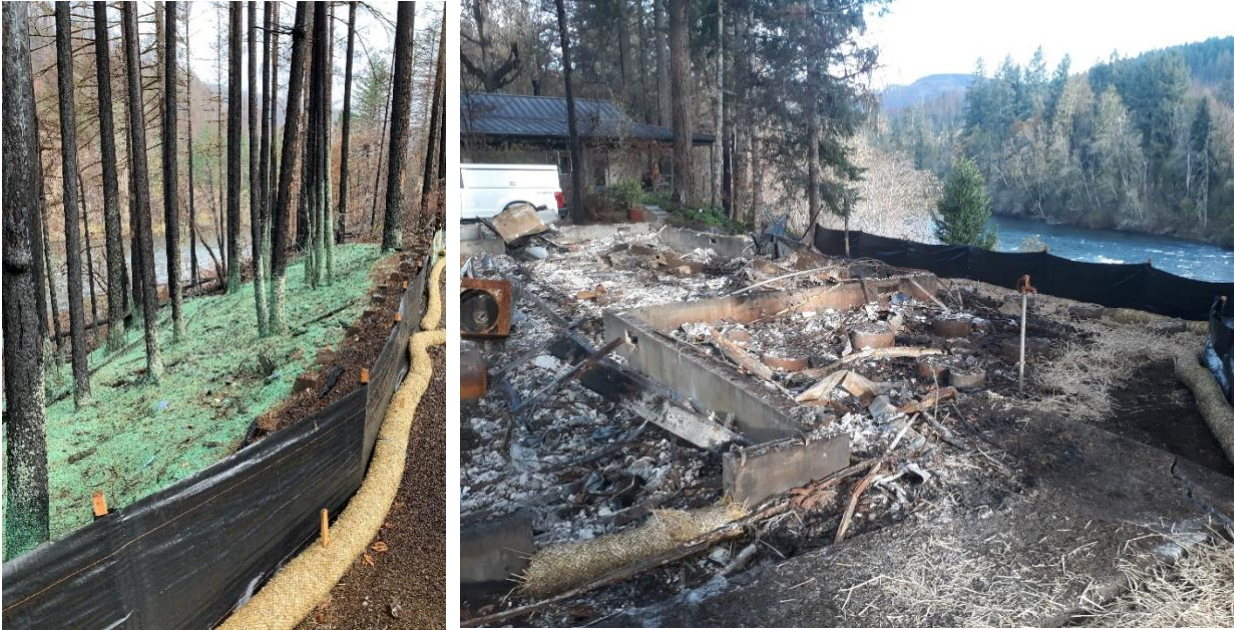
**Figure 7-1: Hydroseeding, Wattles, and Silt Fences**

As of mid-January, over 200 burn assessments have been conducted on landowner properties and over 85 additional erosion control measures were implemented. These erosion control measures included hydroseeding, check dams, wattles, silt fencing, jute mats, mulching, and other measures (See Figure 7-1). LCOG developed a dashboard to track these immediate waste stabilization efforts, burn assessments, and post-assessment best management practices that were implemented:
